检 验 报 告

样品名称 耐根穿刺聚氯乙烯(PVC)防水卷材

种植屋面用防水卷材耐根穿刺性能检测报告

报告编号: 2014B001

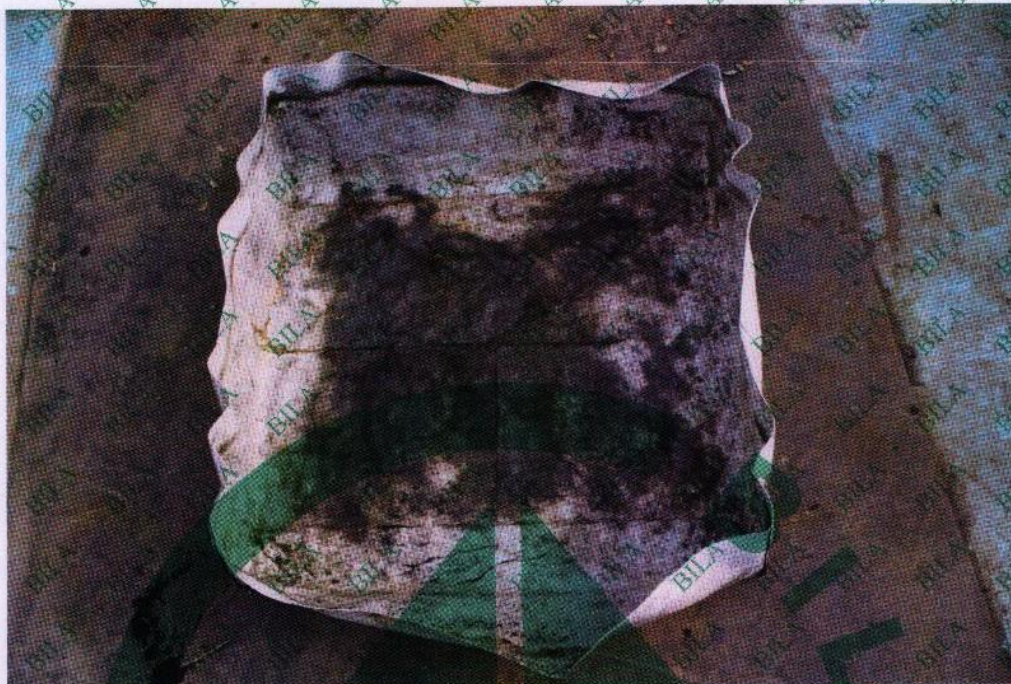
图片3 检测后试样内部

分别于2014年8月30日、2015年2月28日、2015年8月30日进行了中期检测，所有试验箱均未发现明显根穿透现象，2016年2月26日进行了最终的开箱检测，结果见下表及图片3、图片4、图片5。

试样编号	穿透卷材的根的数量			穿入卷材的根的数量		
	卷材平面	无缝角	接缝处	卷材平面	无缝角	接缝处
2014B001-1	0	0	0	0	0	0
2014B001-2	0	0	0	0	0	0
2014B001-3	0	0	0	0	0	0
2014B001-4	0	0	0	0	0	0
2014B001-5	0	0	0	0	0	0
2014B001-6	0	0	0	0	0	0

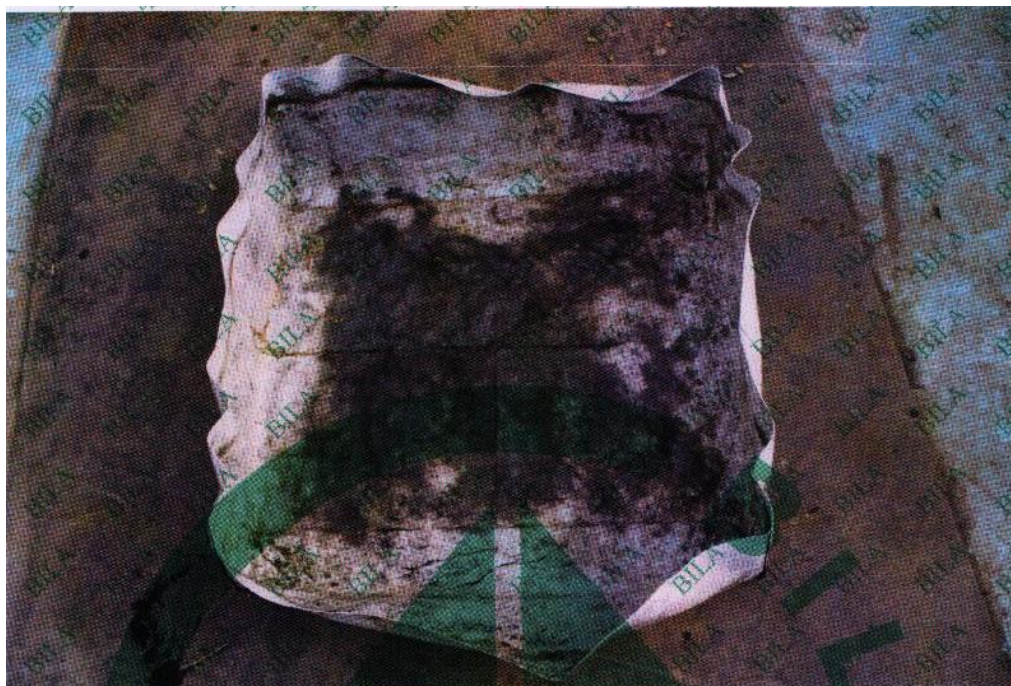
Photo 3 The inside of sample box after test

The middle inspections were done on Aug. 30th, 2014, Feb. 28th, 2015, Aug. 30th, 2015 individually, and no obvious root invading phenomenon has been observed. The final open-box inspection was done on Feb. 26th, 2016. See the photo 3, photo 4 and photo 5 for the results.

Sample No.	The quantity of root invading in the membrane			The quantity of root invading in the membrane		
	Membrane plane	Corner	Joint	Membrane plane	Corner	Joint
2014B001-1	0	0	0	0	0	0
2014B001-2	0	0	0	0	0	0
2014B001-3	0	0	0	0	0	0
2014B001-4	0	0	0	0	0	0
2014B001-5	0	0	0	0	0	0
2014B001-6	0	0	0	0	0	0
